REVIEW OF FHWA REPORT ON THE FAILURES ON I-795
NEAR GOLDSBORO NORTH CAROLINA
(PRELIMINARY)

Richard E. Root, P.E.
Root Pavement Technology, Inc.

March 3, 2009

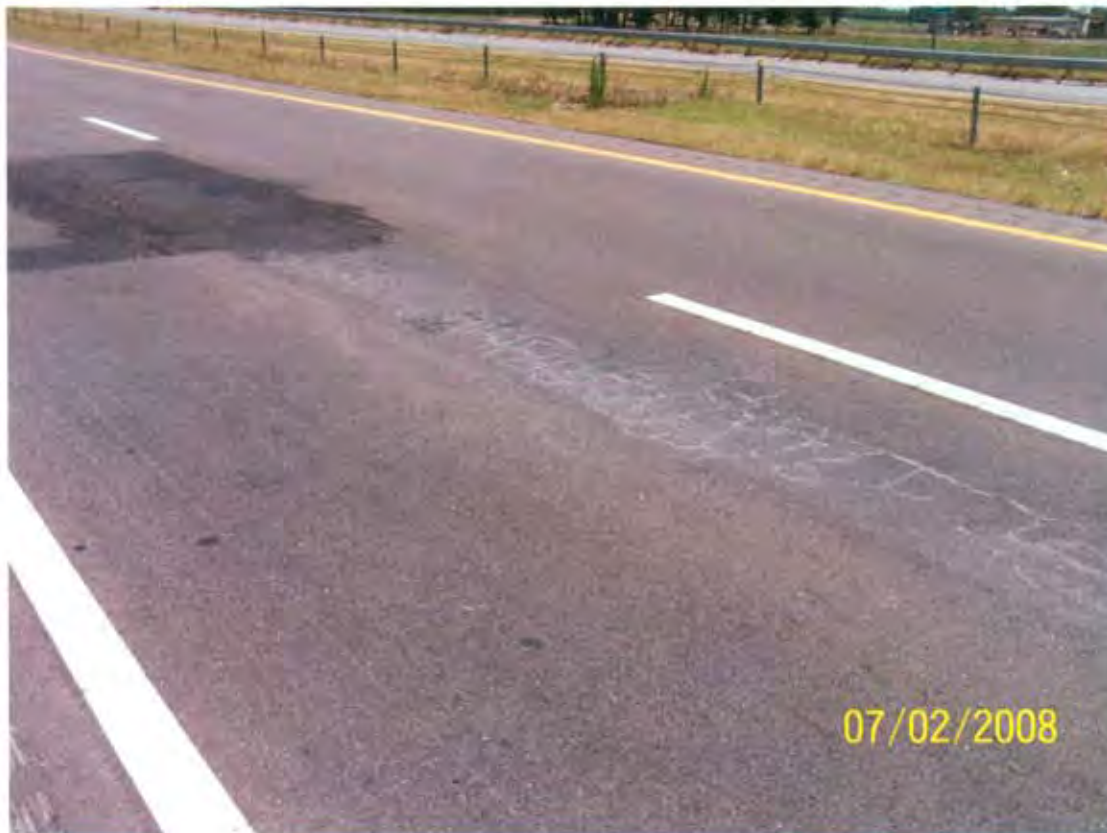
Photograph 1
Southbound Lane Prior to Repair

The visual elements of the limited pavement failure on I-795 reflected in the picture below (alligator/block cracking in the wheel path along with rutting) are classic manifestations of pavement failure due to fatigue (Photograph 1).

The white material outlining the cracking is fine material coming up from the ABC and/or subgrade under the HMA layers. According to the FHWA report, NCDOT observed water coming up through the pavement to the surface. It appears that the pavement is rutted in the cracked area. The section of roadway depicted above has been repaired under a separate contract with NCDOT during the Fall of 2008. I saw no similarly failed areas on the project during my site visit of February 2009.

Fatigue failure is the result of a pavement structure receiving more loading (Equivalent Single Axle Loads (ESALs)) than it is capable of carrying. The pavement with the 8.3-inch HMA layer on the south end of the South Section shows no signs of distress. The same is true for the adjoining projects paved with a similar structural section of approximately 8 inches of HMA.

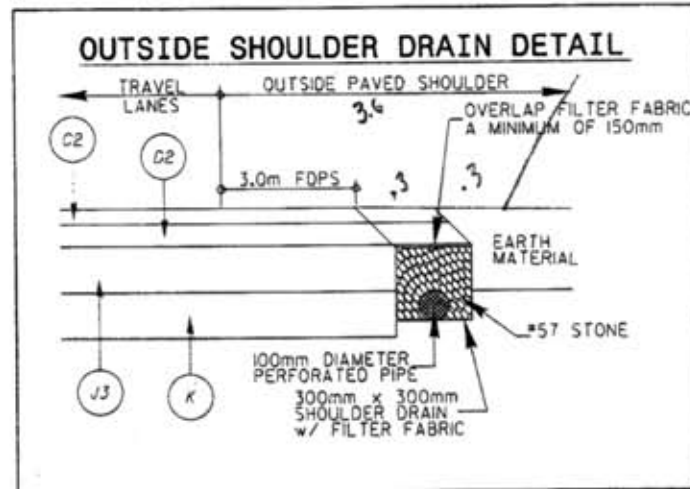
Figure 1

Pavement sections built without shoulder drains have a much greater chance for poor performance. This is demonstrated in NCDOT's plan detail drawing for shoulder drains for the South Section of the project (Figure 1). In the drawing, "K" represents the treated subgrade material and "J3" the 11 inches of ABC. The "earth material" shown to the right of the drain is a soil material intended to grow grass and resist erosion due to rainfall.

When the shoulder drain is not present, the "earth material" acts as a dam and holds the water in the pavement structure, creating a bathtub effect. Visual observation made during my February 2009 site visit indicates water standing and/or running in the ditches and woods near the areas of pavement failure. The possibility of trapped water in the pavement could explain the low strength values measured in the failed areas by the FWD testing.

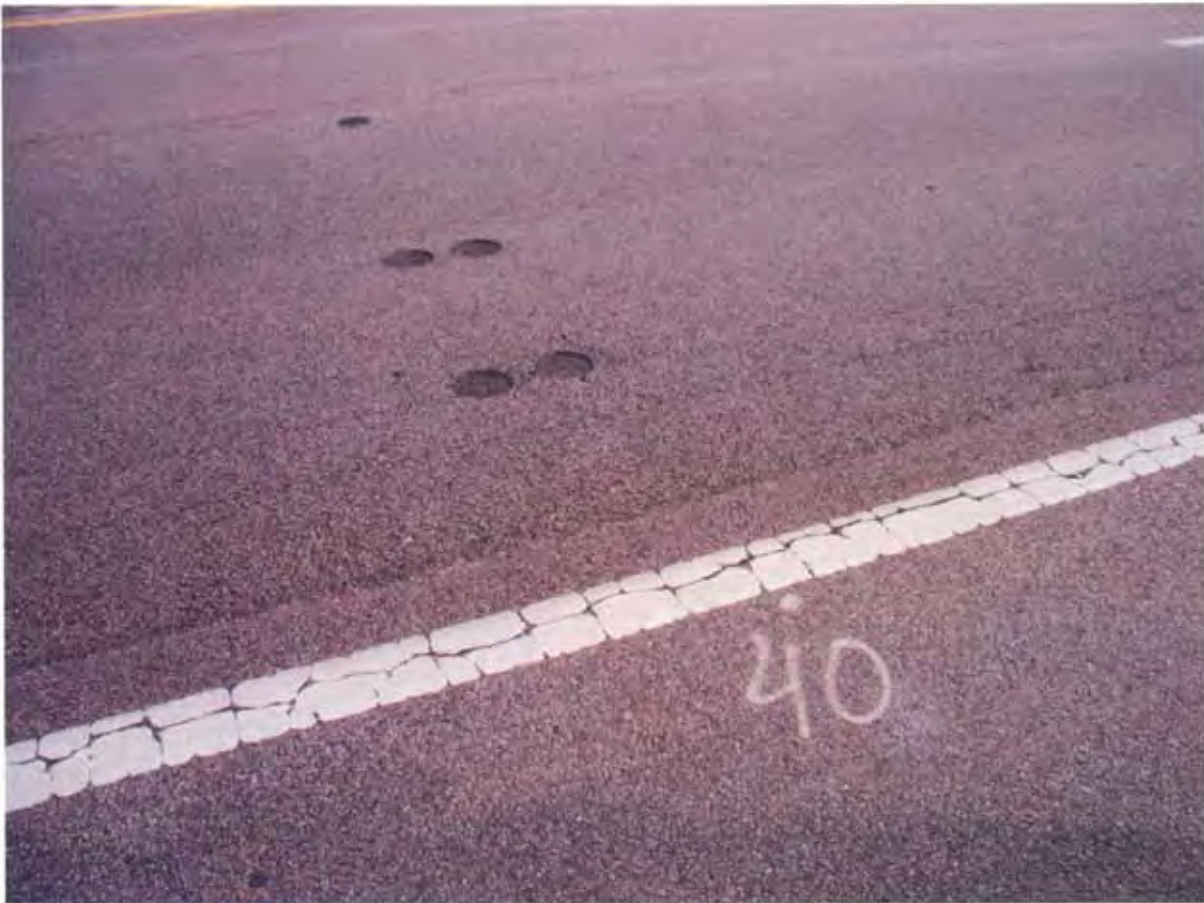
Photograph 2
Core Sample 40 - First Forensic Study

Photograph 2 demonstrates that the A and C cores and B and D cores were taken close together on the roadway. Given the proximity of the cores, one would expect the air void results to be similar. However, some of the individual data does not reflect these expectations. For example, at core site 120 in the southbound lane, the A and C cores from the outside wheel track had air voids of 9.0 and 5.6 percent, respectively. Since these cores were taken within inches of each other, this is physically impossible based on the type of construction equipment and methods of placement called for in the specifications and used on the project by the contractor. The B and D cores taken from between the wheel tracks show the same confusing results with air voids of 10.4 and 6.3 percent, respectively.

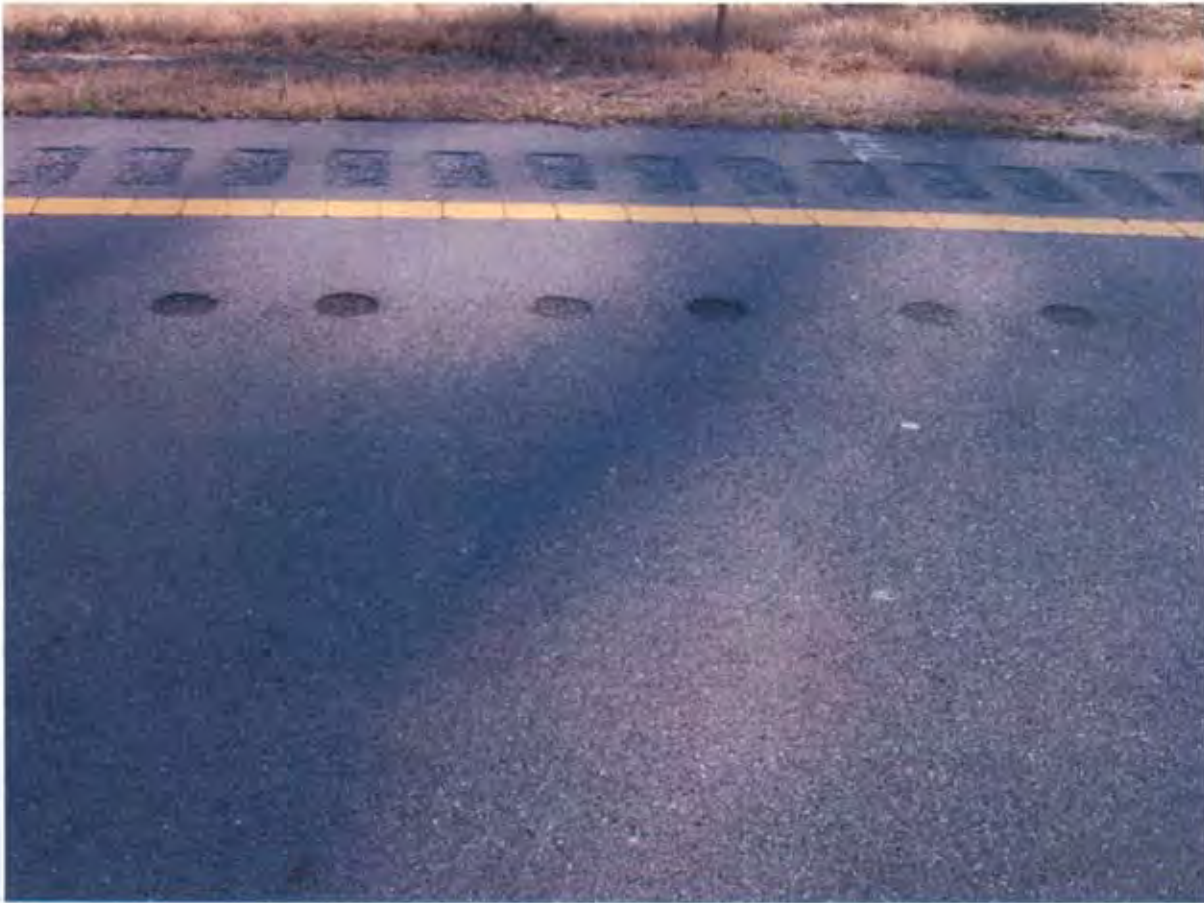
Photograph 3
Core Sampling SB Median Lane for Second Forensic Study

For the second forensic study, six cores were taken from each control strip location as shown in Photograph 3. Two cores (1 and 4) were tested by S. T. Wooten using two test methods, two cores (2 and 5) were tested by the NCDOT project staff using four test methods and two cores (3 and 6) were tested by the Materials and Test staff in Raleigh using four test methods. A summary of the data developed from the three labs along with a comparison to the original QC and/or QA results measured during construction by both NCDOT and S.T. Wooten, are presented in Appendix A for the “First Surface Layer” and “Final Surface”.

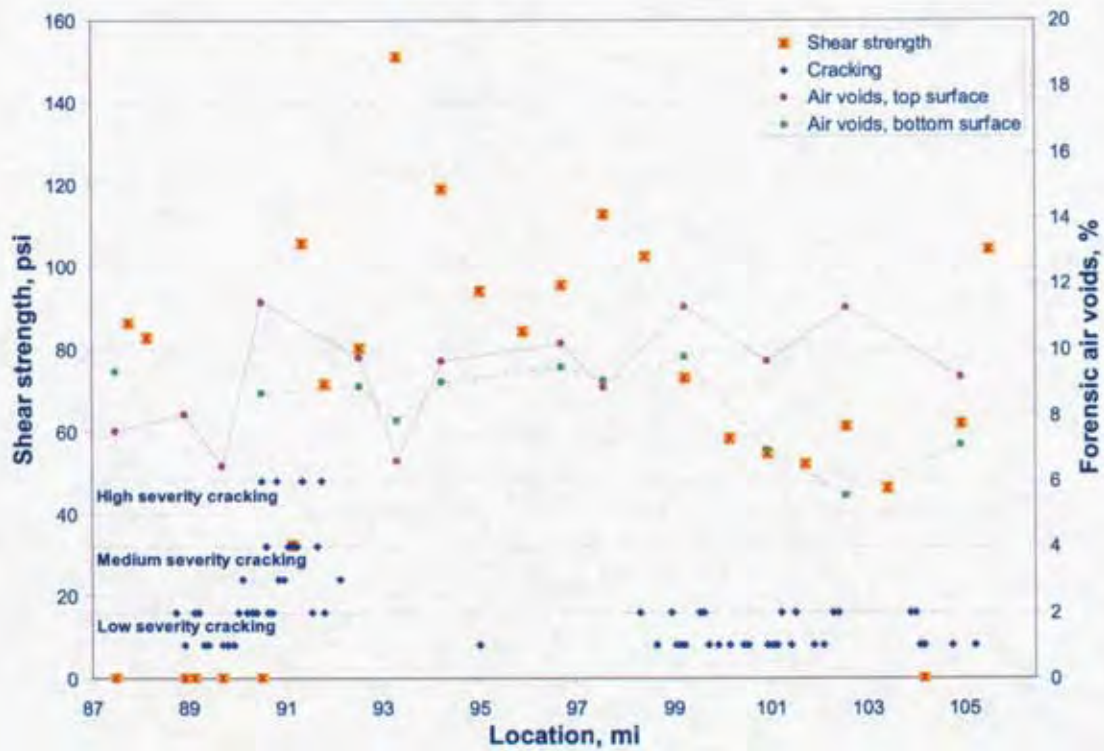
Figure 20. SB I-795 pavement condition and HMA surface layer air-voids.

Comparison of First Forensic Air Voids to Pavement Performance - Figures 20 and 21 in the FHWA report (reproduced below), show that air voids have no relation to pavement performance. For the southbound lane (Figure 20), the “final surface” layer air voids are higher from MP 95 to MP 105, an area of no repairs when compared to the air voids at the south end of the project, where repairs were made. For the “first surface” layer from MP 95 to MP 105, some air voids are higher and some lower than the air voids in the repair areas at the south end of the project.

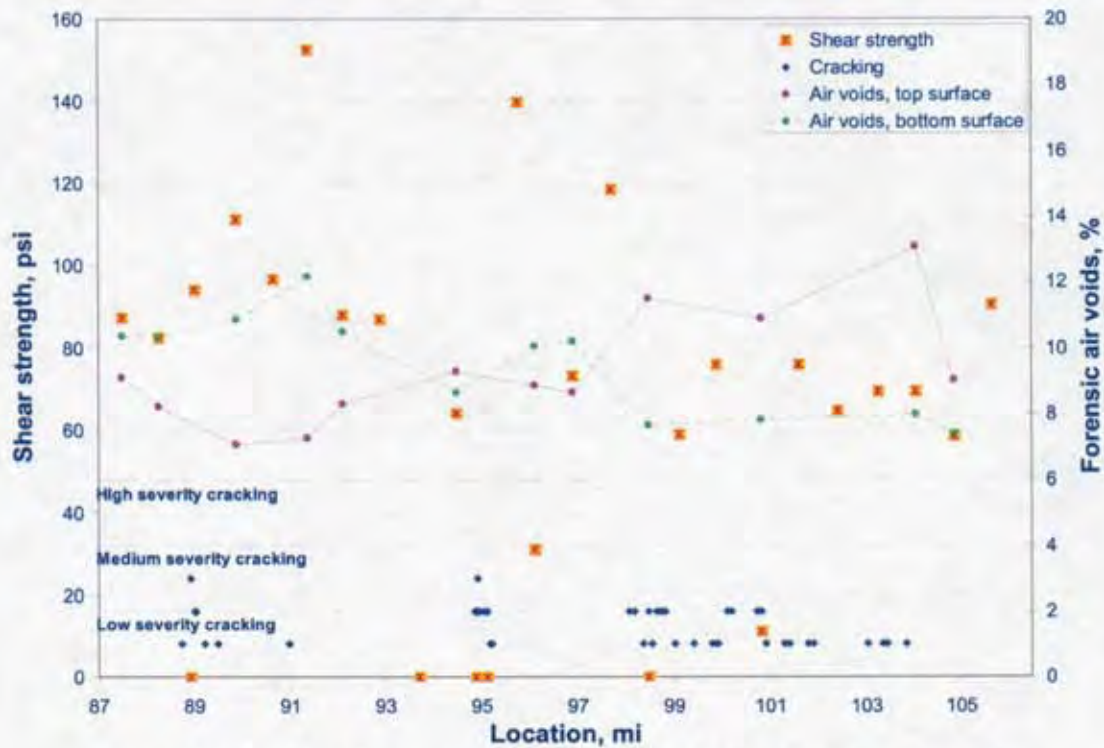
Figure 21. NB I-795 pavement condition and HMA surface layer air-voids.

Results in the northbound lane are similar. The air voids in the “final surface” layer are significantly higher in the non-repair areas from MP 93 to MP105 compared to the south end of the project where the repairs were made. The air voids in the “first surface” layer are slightly

lower in the non-repair areas.
